# Manhole Inspection Summary

Manhole # S35YY1002MH

**Inspection** ☐ Is Incomplete Rating: **4) Poor**

**Location** Address: **328 SAINT DUNSTANS RD**

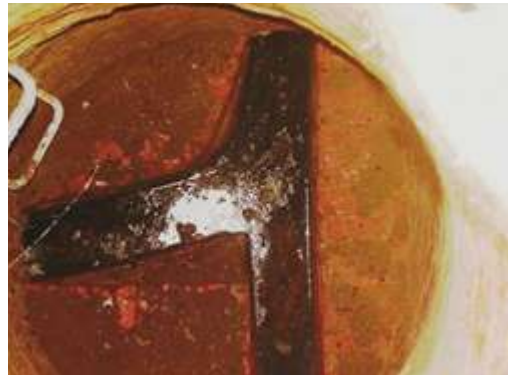
Top View

Evidence of surcharge - Bench debris.  
Channel debris.

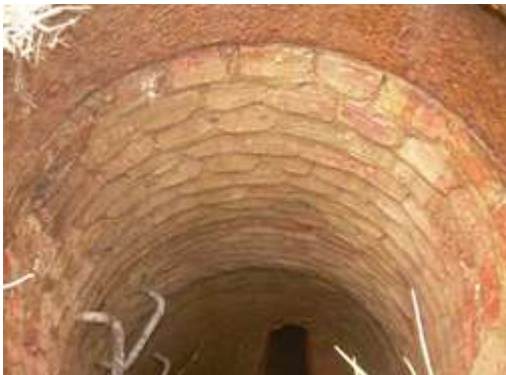
Defect

Condition: ☐ Sound ☐ Cracked ☐ Root Intrusion ☐ Loose Brick ☒ **Deteriorated**

Infiltration: ☐ None ☒ **Joint** ☐ Cracks ☒ **Mortar** ☐ Roots ☐ Wall

Infiltration: ☐ None ☐ Joint ☐ Cracks ☒ **Mortar** ☐ Roots ☒ **Wall**

Adjustment and Corbel deterioration and  
infiltration.

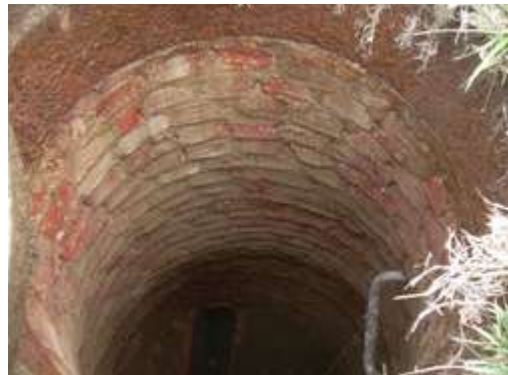
Defect

Adjustment and Corbel deterioration and  
infiltration - other side.

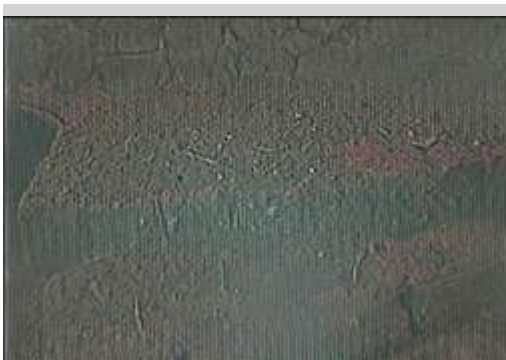
Defect

Condition: ☐ Sound ☐ Cracked ☐ Root Intrusion ☐ Loose Brick ☒ **Deteriorated**

Infiltration: ☐ None ☐ Joint ☐ Cracks ☒ **Mortar** ☐ Roots ☐ Wall

Condition: ☐ Sound ☐ Cracked ☐ Root Intrusion ☒ **Deteriorated** ☐ Leaks ☐ Debris

Barrel deterioration and infiltration.  
Channel deterioration. Bench debris.

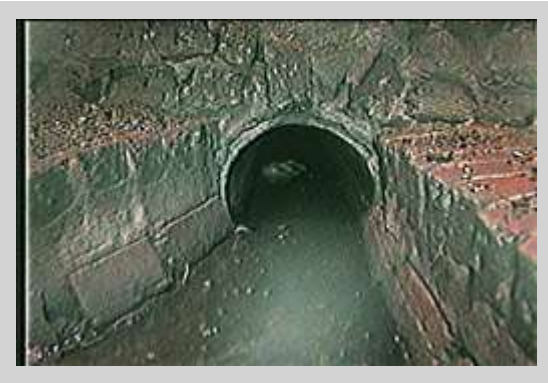
### 8 in. Circular Gravity Sewer Pipe Out @ 12 O'Clock

Barrel deterioration and infiltration. Channel deterioration.

Deposits: ☐ None ☒ **Mud** ☐ Sludge ☒ **Debris** ☒ **Grease**

Infiltration: **Evidence** Pipe Seal Cond: **Cracked**

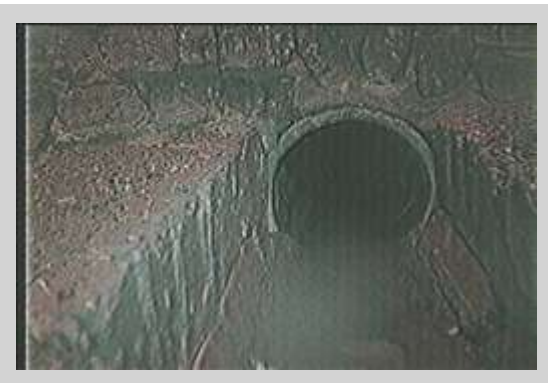
### 8 in. Circular Gravity Sewer Pipe In @ 6 O'Clock

Barrel deterioration and infiltration. Channel deterioration.

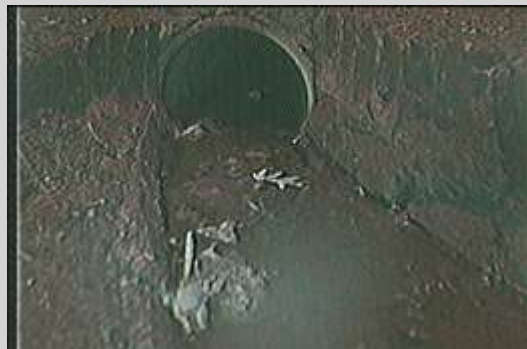
Pipe In @ 8 O'Clock

Channel deterioration and debris.

Deposits: ☐ None ☒ **Mud** ☐ Sludge ☒ **Debris** ☐ Grease

Infiltration: **Evidence**

Pipe Seal Cond: **Cracked**
